Manhole Inspection Summary

Manhole # S61S__001MH

Location Address: **1602 S.Ponca St.**

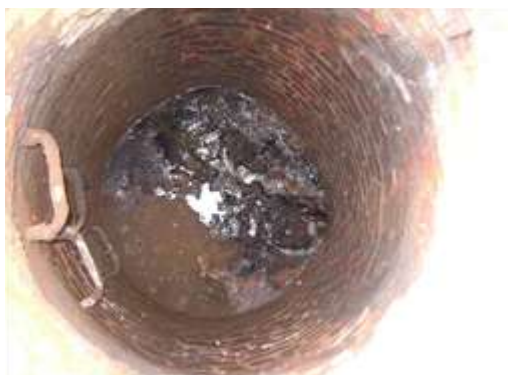
Defect 1

Surcharge ☒ **Evidence Of Surcharge** Depth: **1** (ft.) ☐ Active Surcharge Present

Surcharge over bench.

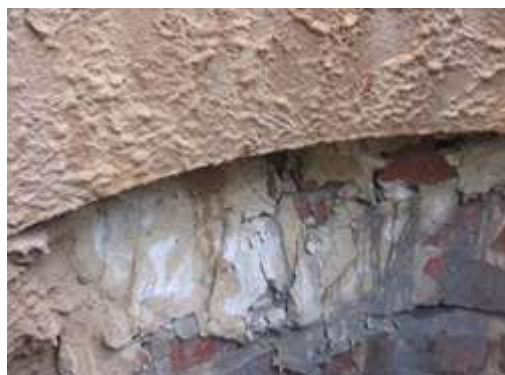
Defect 2

gap under frame seal

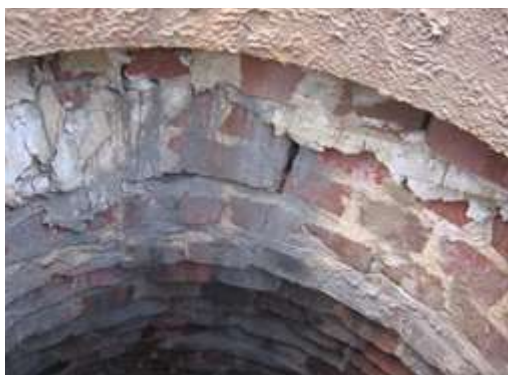
Defect 1

Condition: ☐ Sound ☐ Cracked ☐ Root Intrusion ☒ **Loose Brick** ☒ **Deteriorated**

Infiltration: ☐ None ☒ **Joint** ☐ Cracks ☐ Mortar ☐ Roots ☐ Wall

Loose Bricks

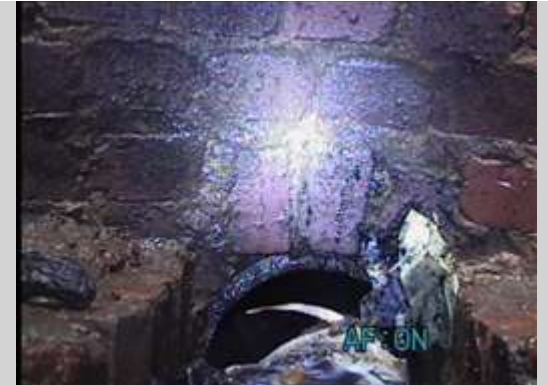
12 O'Clock Outflow

Pipe Height: **8.4** (in.) Rod and Bar (Angled)
Pipe Material: **Clay** ☐ Pipe Lined
Invert Depth: **9.67** (ft.) Flow Characteristics: **Slow**
Deposits: ☒ None ☐ Mud ☐ ~~Gravy~~ ☐ Debris ☐ Grease
Silt Depth: (in.) Deposits Extent:
Infiltration: **None** Pipe Seal Cond: **Sound**

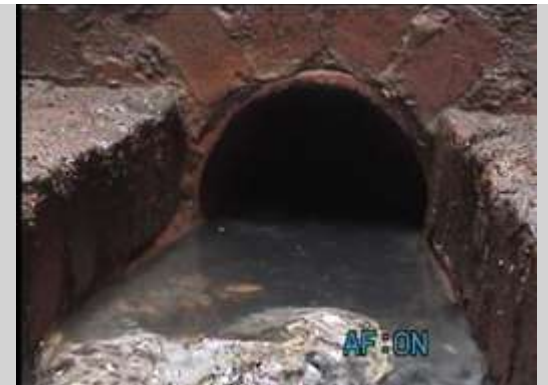
9 O'Clock Inflow

Pipe Height: **8.4** (in.) Rod and Bar (Angled)
Pipe Material: **Clay** ☐ Pipe Lined
Invert Depth: **9.25** (ft.) Flow Characteristics: **Slow**
Deposits: ☐ None ☐ Mud ☒ ~~Gravy~~ ☐ Debris ☐ Grease
Silt Depth: **0.75** (in.) Deposits Extent: **Light**
Infiltration: **None** Pipe Seal Cond: **Sound**
